# **Structural Qualification Testing and Operational Loading on a Fiberglass Rotor Blade for the Mod-0A Wind Turbine**

Timothy L. Sullivan  
National Aeronautics and Space Administration  
Lewis Research Center

**March 1983**

Prepared for  
**U.S. DEPARTMENT OF ENERGY**  
**Conservation and Renewable Energy**  
**Wind Energy Technology Division**

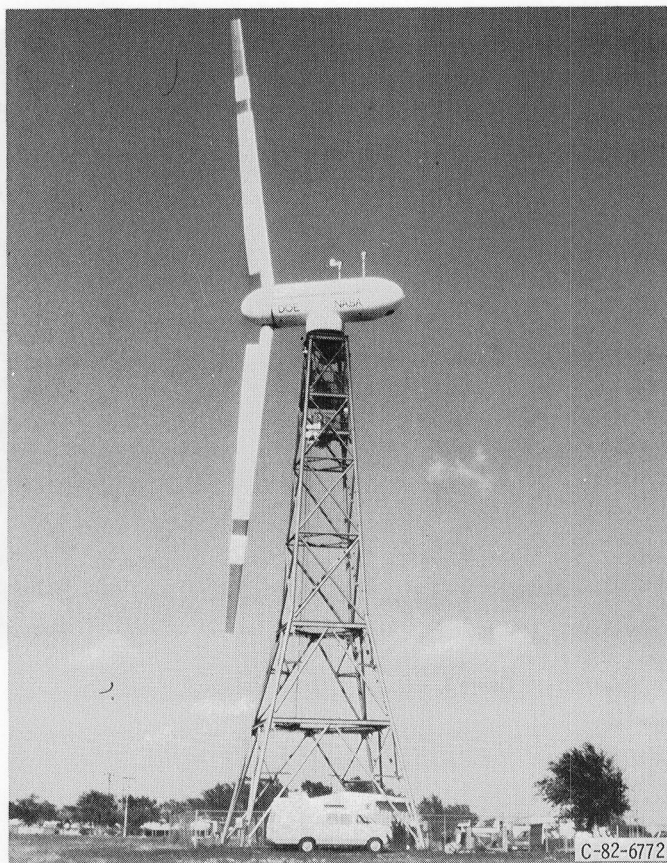
Figure 1. - 200-kW Mod-0A wind turbine with SCI fiberglass blades at Clayton, NM.

The SCI fiberglass/epoxy blade was designed to operate on the Mod-OA wind turbine, a horizontal-axis machine rated at 200 kW (ref. 1). Its two-bladed rotor is 38.1 m (125 ft) in diameter and operates downwind of the tower. Rotor speed is 40 rpm. The hub is rigid with a precone angle of  $7^\circ$  and is elevated 30.5 m (100 ft). Power control is achieved by full-span pitch of the blades. A photograph of a Mod-OA wind turbine is shown in figure 1.
